OPERATING EXPERIENCE WEEKLY SUMMARY

Office of Nuclear and Facility Safety

June 25 - July 1, 1999

Summary 99-26

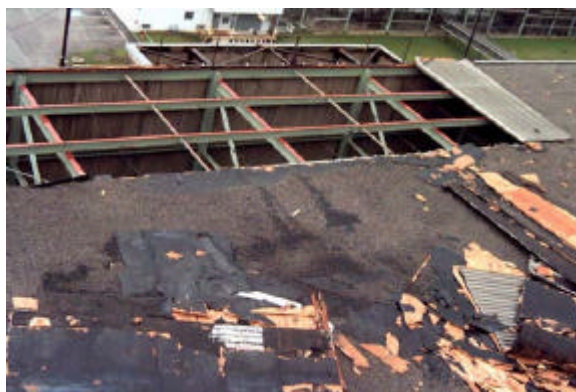
On the night of June 24, 1999, at the East Tennessee Technology Park, powerful localized winds damaged the K-33 Gaseous Diffusion Building. The winds displaced refuse dumpsters by as much as 75 ft and blew an aluminum building up and over a security fence and into power lines. Heavy rain accompanied the high winds, and lightning struck power transformers, which caused a loss of power to K-33 and some surrounding buildings. The wind pulled siding and roofing material away from the structure and made three large holes in the roof, the largest of which was approximately 20 ft by 80 ft, and a 20-ft-diameter hole in the south wall 20 to 30 ft above ground level. Figures 1 and 2 show two of the holes. Personnel working in the building were not injured and cursory inspections of the building do not reveal any structural damage. The intrusion of water into an area containing fissile material, significant amounts of enriched uranium in equipment, and hazardous and mixed waste on floor areas could spread contamination and cause a criticality accident. (ORPS Report ORO--BNFL-K33-1999-0006)

Figure 1-1. Roof Hole

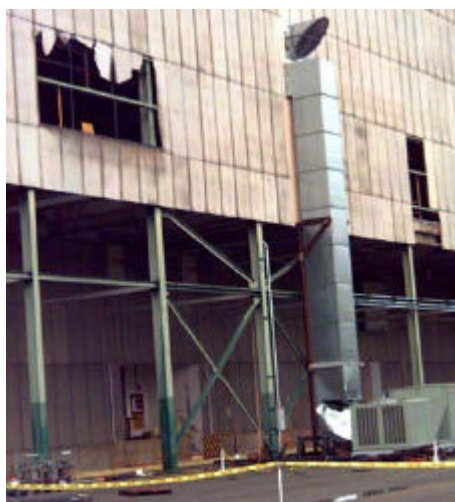
Figure 1-2. Side-Wall Hole
